ESOM I and II Final Report

Alessandro Bocconcelli, Henri Berteaux, Daniel E. Frye
and Dr. Bryce Prindle

Woods Hole Oceanographic Institution
Woods Hole, Massachusetts 02543

November, 1991

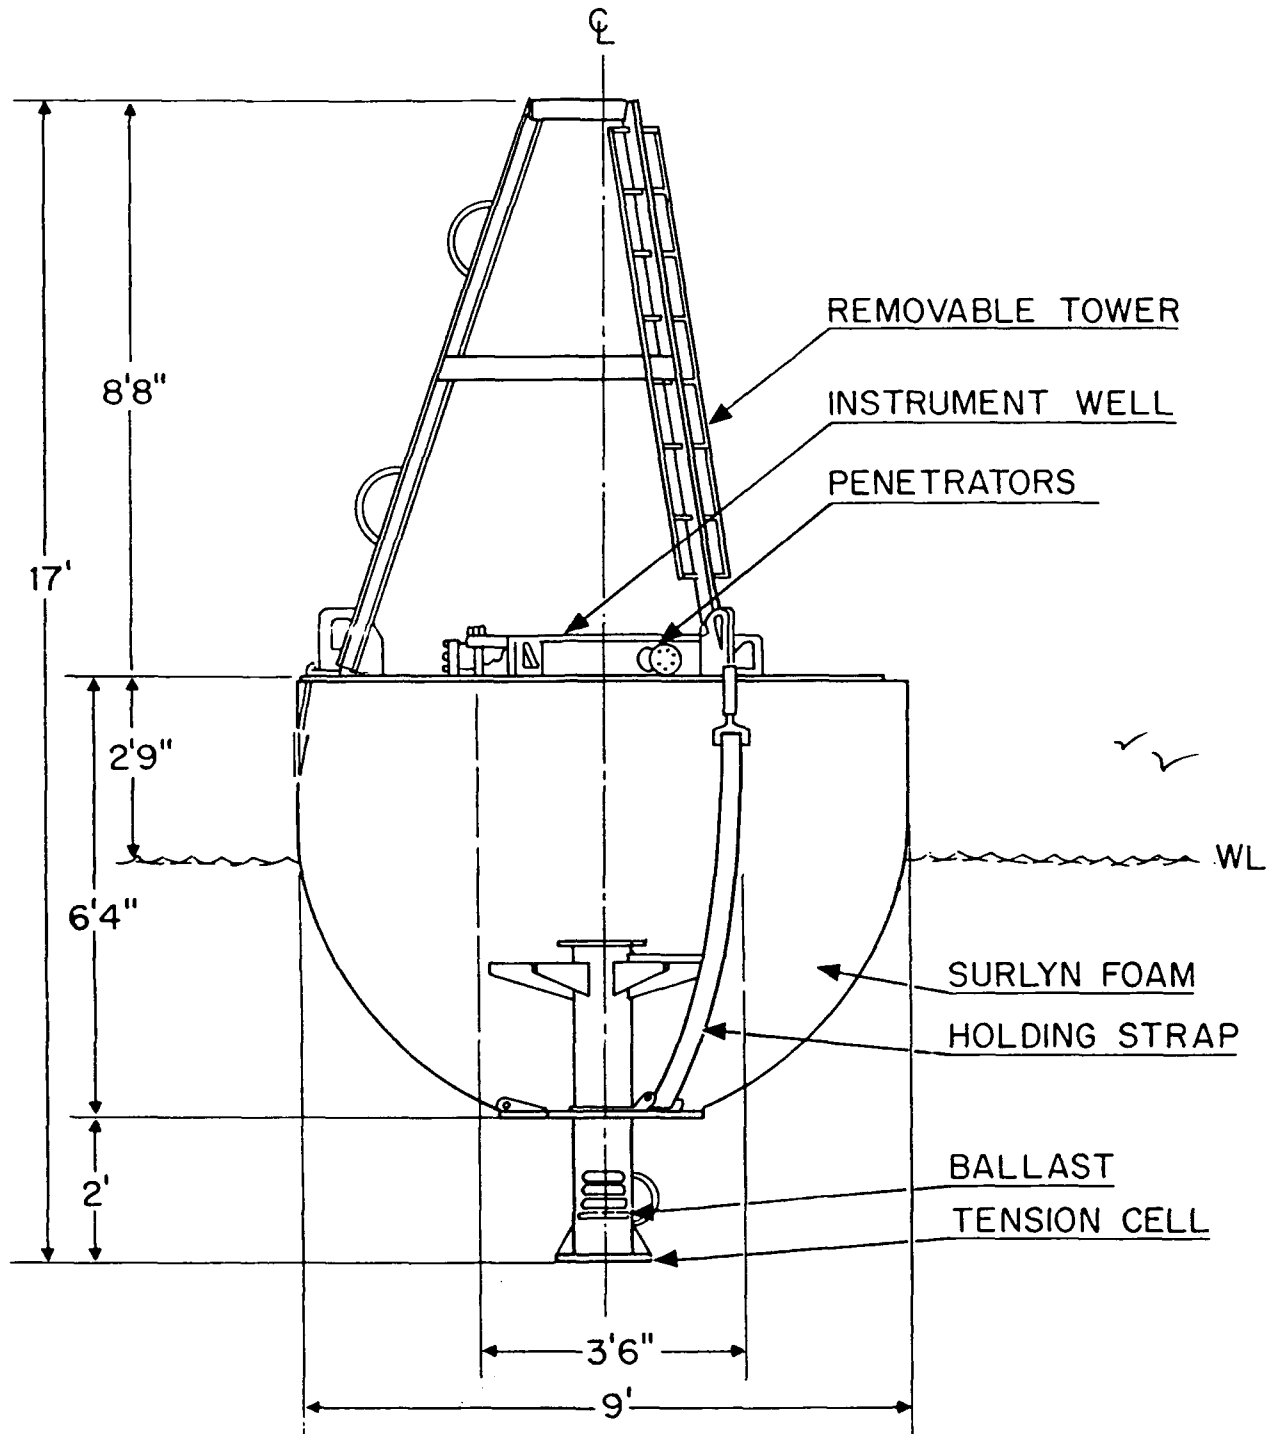
FIGURE 3: ESOM buoy

A preliminary inspection showed no signs of material degradation due to environmental agents. No discoloration due to UV action was noticed on the SURLYN foam. No cracks, abrasion or punctures were found on the hardened skin of the foam body. Light biofouling (algae) and some goose barnacles were growing on the immersed section of the hull, which had been coated with antifouling paint. The nylon straps (stitching and hardware) appeared to be in good condition. Overall, the buoy retained its hemispherical shape with no evidence of permanent deformation or bumps.

The aluminum (6061-T6) structure, including the instrument well, deck, tower and point of attachment, was inspected and found to be in

good condition. The buoy keel, also made of aluminum (5086-H34) was covered with biofouling, but when cleaned, no evidence was found of corrosion or welding cracks. The tension cell was removed from it, and the hardware, including the electrical harness, appeared to be intact. The instrument well was found completely dry with no sign of water infiltration or moisture accumulation. The electronics and batteries were removed from the well; the meteorological sensors, antennae and electrical harness were stripped off the tower. All these components were then shipped to WHOI on the R/V Oceanus.

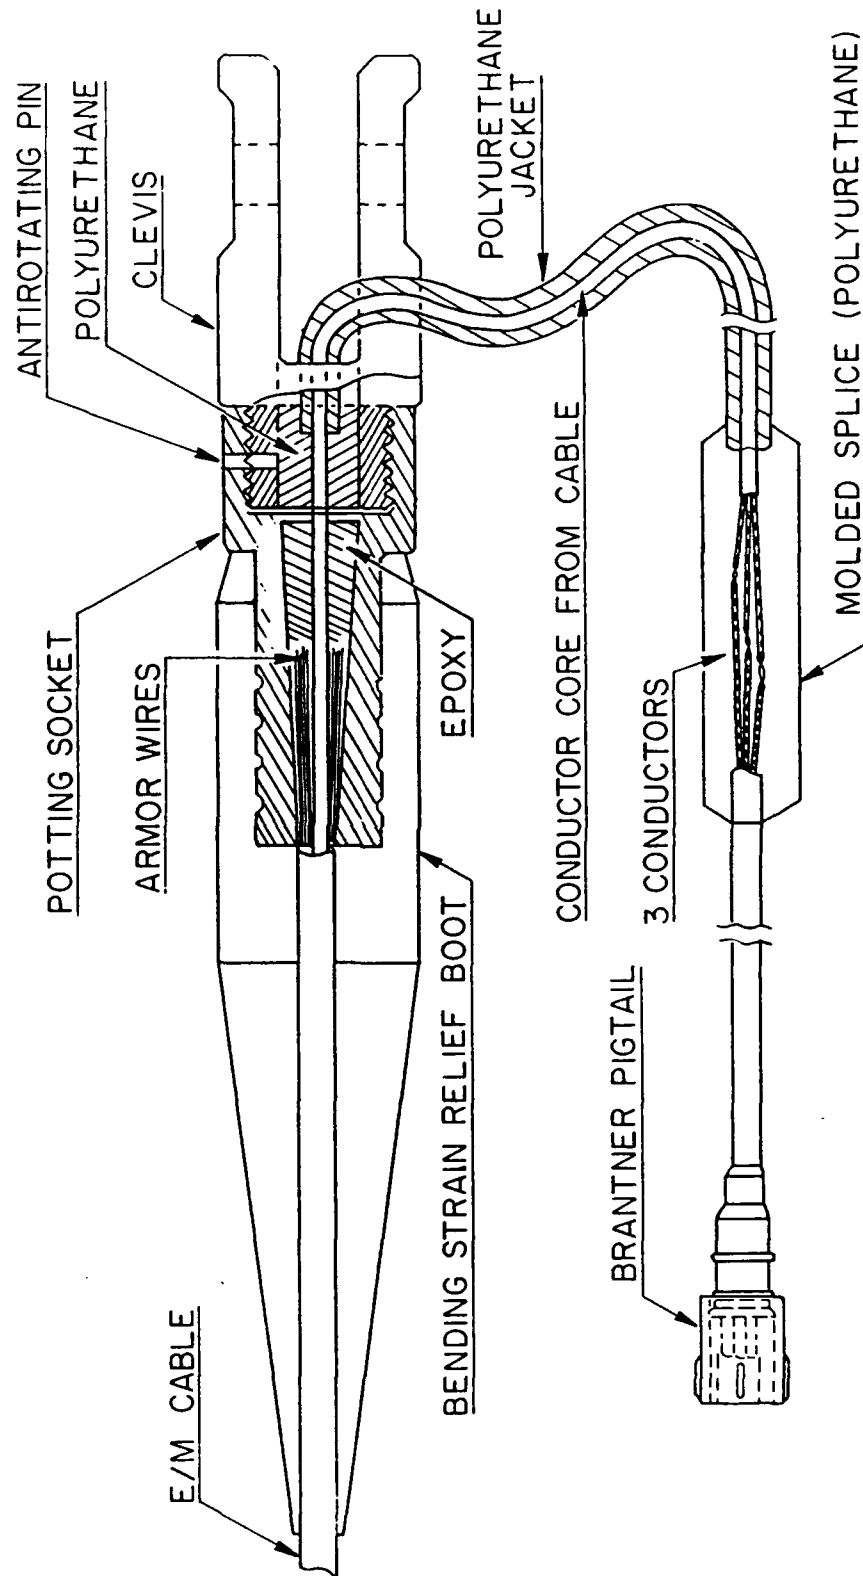
FIGURE 5: In-house epoxy termination

Two types of EM cable terminations, both designed and built at WHOI, were tested during the ESOM experiment. The "in house" epoxy termination (Fig. 5) for 3x19 EM cables had been previously during the six month STEM experiment with excellent results [9]. The new swage socket termination for the 3x18 EM cables (Fig. 6) was deployed at sea for the first time.
